MORNING-GLORY SHAFT SPILLWAYS:  
PERFORMANCE TESTS ON PROTOTYPE  
AND MODEL

by A. J. Peterka, A.M. ASCE

HYDRAULICS DIVISION

## MORNING-GLORY SHAFT SPILLWAYS: PERFORMANCE TESTS ON PROTOTYPE AND MODEL

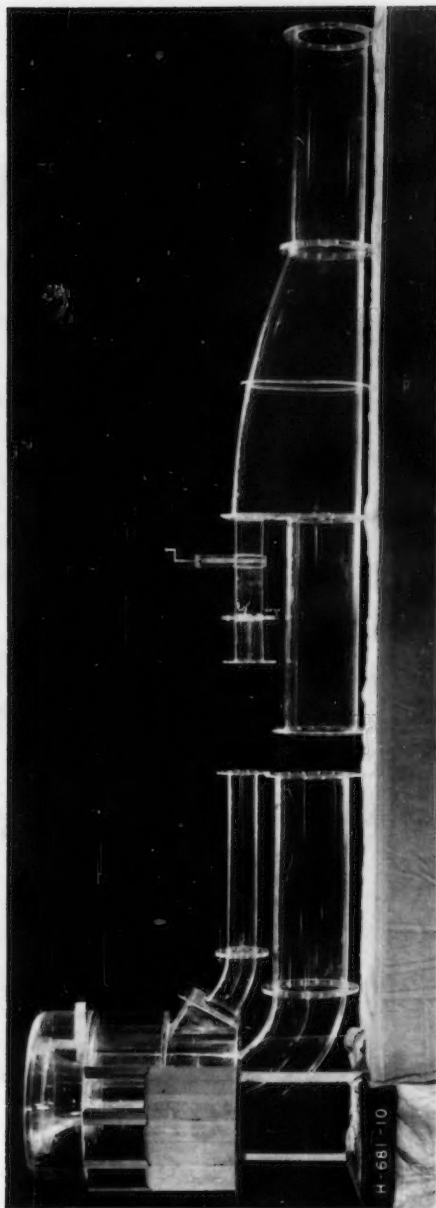
Fig. 3

The essential parts of the spillway and outlet works were modeled in transparent plastic. The intake for the outlet works encircles the spillway shaft. Outlet works discharge is controlled by the slide gate shown.

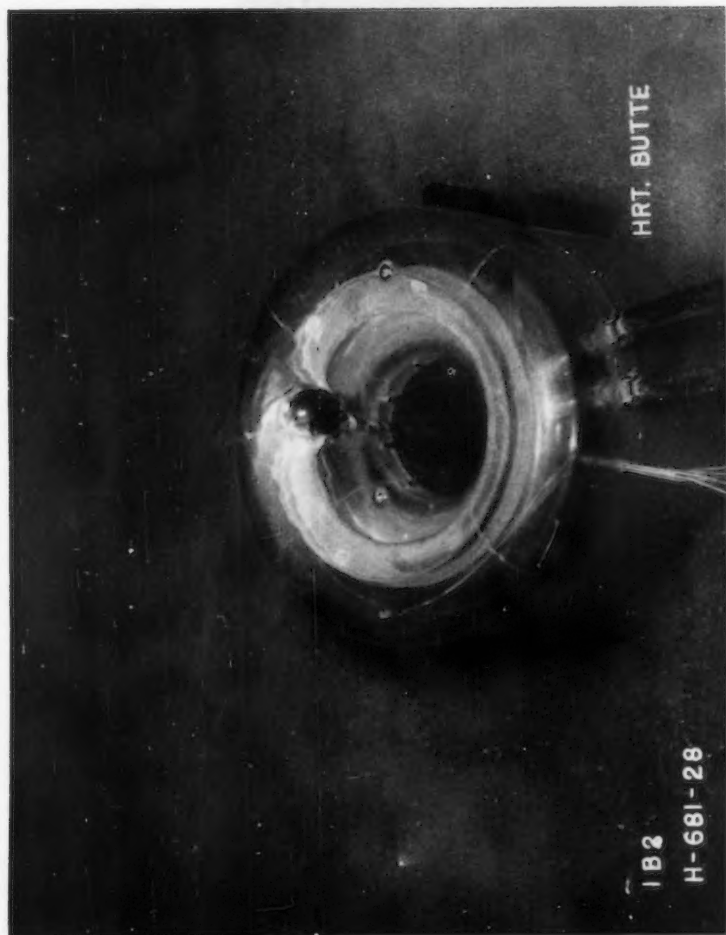
Fig. 4

A violent vortex was formed in the spillway for heads above the submergence point. The tail of the vortex extended down into the horizontal tunnel.

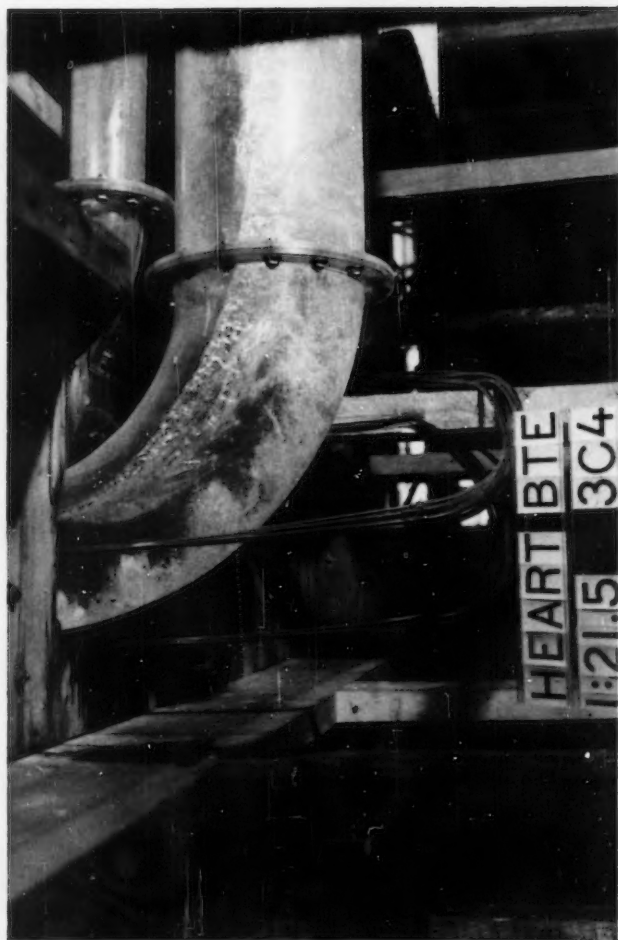
Fig. 6

Flow in the vertical bend for a discharge of 3,750 cfs. Note the smooth flow in the bend and the flat water surface produced by the deflector at the base of the vertical shaft. 1/15,000-second exposure shows air entering flow in bursts. To the eye air flow appeared continuous.

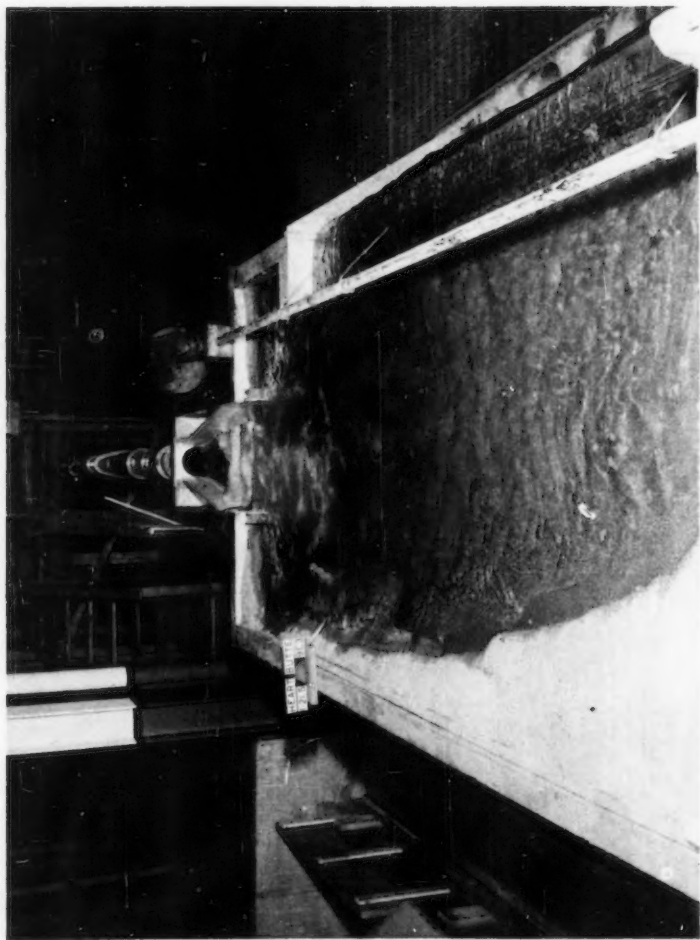
Fig. 9

The recommended basin, shown in operation, was reduced to minimum dimensions consistent with acceptable performance.

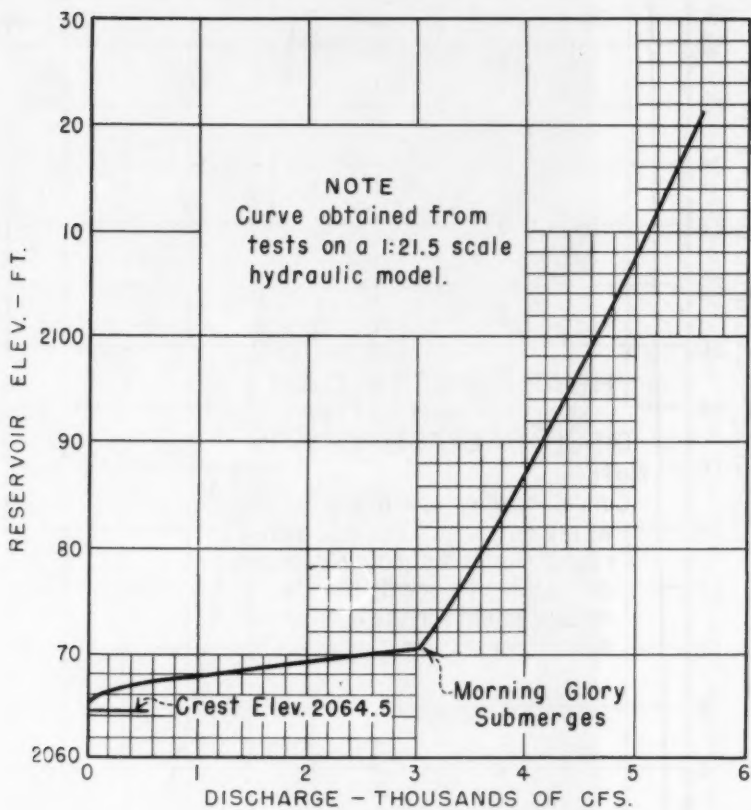
FIGURE 12.

During the model tests it was noticed that for certain arrangements of the structure the transition from free to submerged flow, and vice versa, was accompanied by violent surging in the vertical shaft. In some cases the unstable flow condition existed over several feet of change in reservoir elevation. A mushroom-shaped column of water rose and fell in the shaft, causing excessive splashing and turbulence. In addition to giving poor hydraulic conditions it was feared that the prototype structure would be subjected to objectionable forces and vibration. Consequently, the structure recommended for field construction was developed by model tests to provide a minimum transition range, i.e., less than 0.2 foot prototype. The rating curve determined by model tests, see Figure 12, indicates the definite change from one type of flow to the other.

On April 29, the reservoir had fallen to 0.8 foot below the critical submergence point and although the "mushroom" was lower in the shaft, it was still stable with no rising and falling evident. Again the flow had passed through the critical range during the night when photographs and observations were impracticable. Indications are that the prototype submerged at about the headwater elevation shown by the break on the curve of Figure 12 and that the change occurred abruptly as indicated on the model curve.

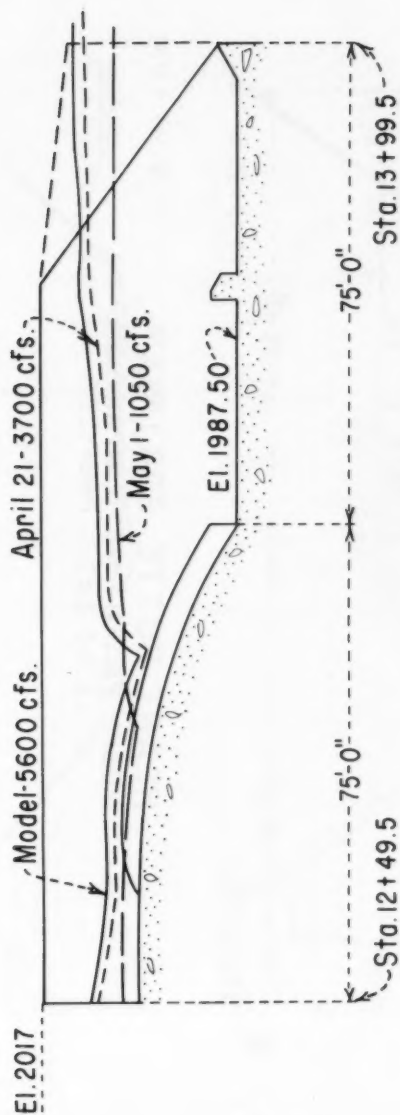
FIGURE 26

Water-surface profiles were measured in the prototype for discharges of 3,700, 3,300, 2,350, and 1,050 cfs. These are shown in Figures 26 and 27, along with the profile obtained during the model tests for 5,600 cfs. Although no exact comparisons can be made, the prototype profiles seem to be in good agreement with the model profile. If differences do exist, they are probably due to the greater air entrainment in the prototype, making the prototype profiles slightly higher than those in the model for the same discharge.

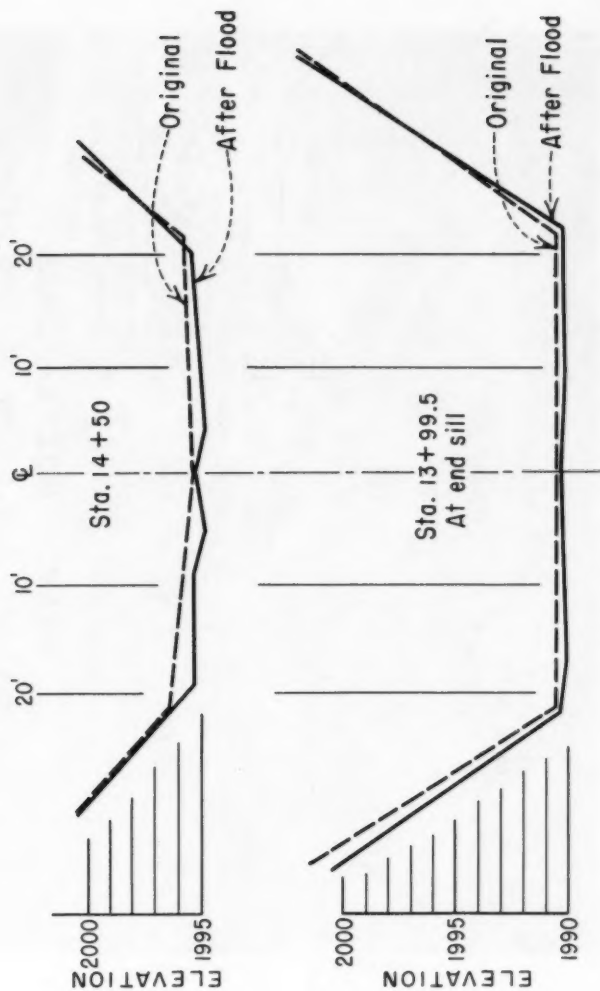
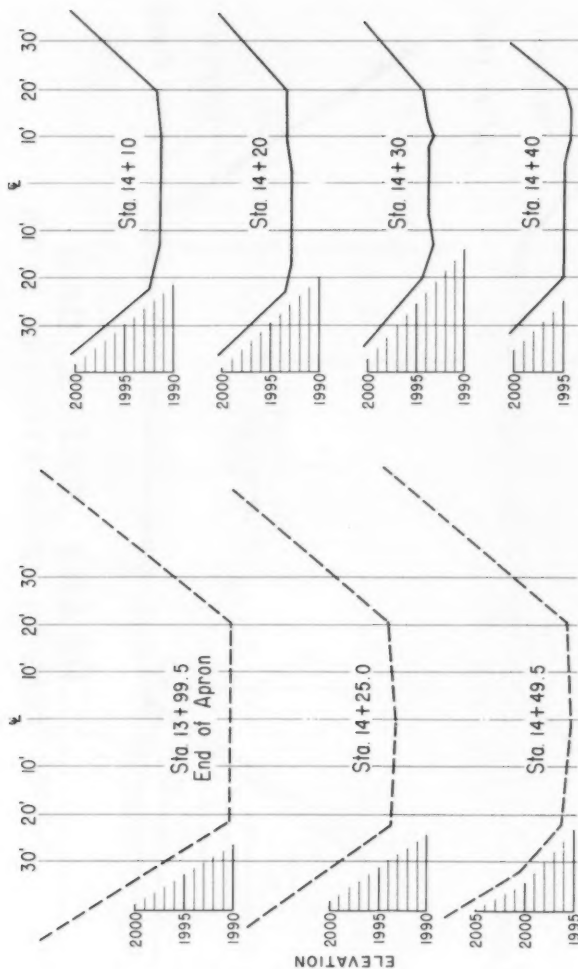
FIGURE 28

Before the run-off in the Spring of 1950, cross sections had been taken in the prototype channel on May 31, 1949. Following the 1950 run-off, cross sections were again taken on June 15, 1950. Cross sections for both dates at a station located just downstream from the end sill and at a station 50 feet downstream from the sill are shown in Figure 28. These typical sections show the maximum erosion depth to be less than 12 inches. Close to the end sill there

is no significant erosion. Using all the cross sections taken, see Figures 28 and 29, calculations made to determine the volume of material moved indicated that less than 20 cubic yards of material was removed from the channel bottom during the entire run-off.

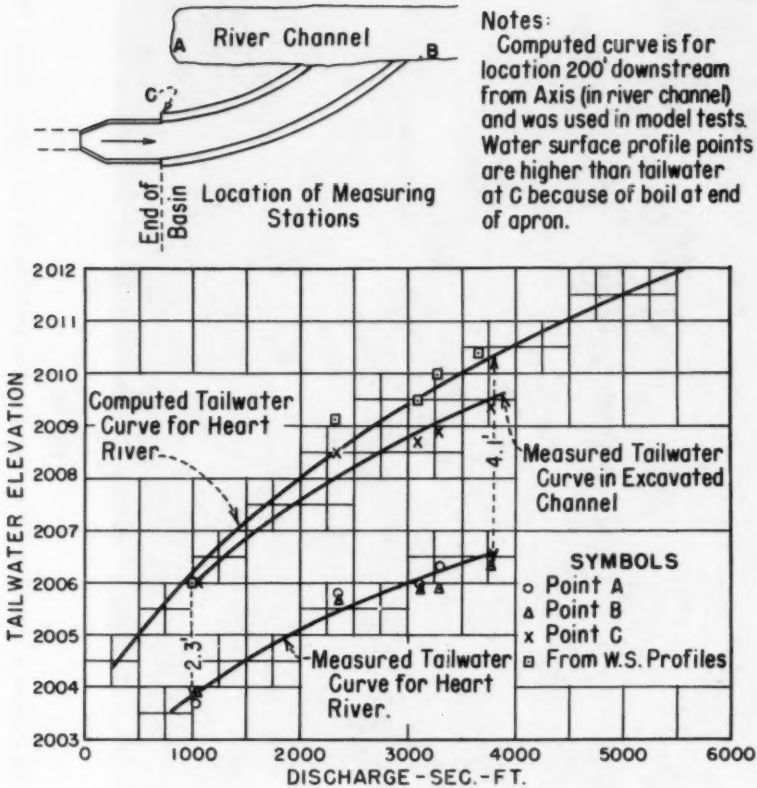
FIGURE 31

The topography in the model extended only a short distance downstream from the stilling basin into the excavated channel and did not include any portion of the Heart River, see Figure 9. Tail-water elevations were set by means of an adjustable tail gate located at the end of the model using a computed curve, tail-water elevation versus discharge, for the Heart River. The excavated channel was designed so that the tail-water elevation to be expected would be essentially the same as that to be expected in the river channel. The tail-water curve used in the model tests and shown in Figure 31 was computed for a point located 200 feet downstream from the axis of the dam in the Heart River.

During the prototype operation it was readily apparent to the unaided eye that the tail-water elevation in the river was considerably lower than that in the excavated channel. Water entering the river from the channel had a steep surface slope and a much higher velocity than anticipated, see Figure 32. Observations, however, were not sufficient to establish whether the tail water in the channel was too high or that in the river too low. Levels were run, consequently, to determine the tail-water elevation at four separated points for five different discharges. The location of these points, together with the tail-water elevation and discharge are shown in Figure 31, plotted below the tail-water curve used in the model tests. These data show the computed tail-water curve to be 2.3 feet higher at 1,000 second feet and 4.1 feet higher at 3,600 second feet than the actual measured points in the Heart River. Tail-water elevations measured in the excavated channel more nearly coincided with the computed curve, but at 3,600 second feet the elevation at Point C, Figure 31, taken in a quiet area adjacent to the wing wall at the end of the apron, was 1 foot below
